ARBORIST REPORT
57 BATTEAUX ROAD DEVELOPMENT
NOTTAWA, SIMCOE COUNTY

PREPARED FOR:
NOTTAWA LIMITED PARTNERSHIP

PREPARED BY:
C.F. CROZIER & ASSOCIATES INC.

CFCA FILE NO. 1953-6180

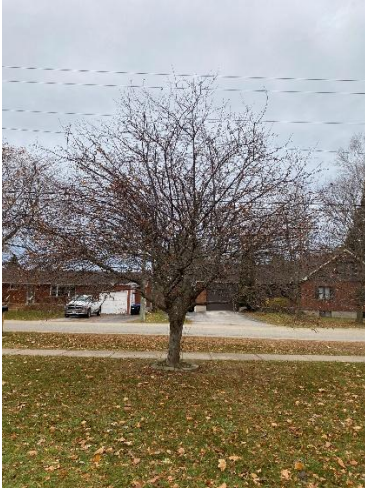
TREE ID: 1
ACTION: **Remove**

- i) **Ten (10)** privately owned trees are on the subject property will require **removal and Compensation**. Trees #1, 6-10, 13, 27, 61 & 66, are proposed to be removed.

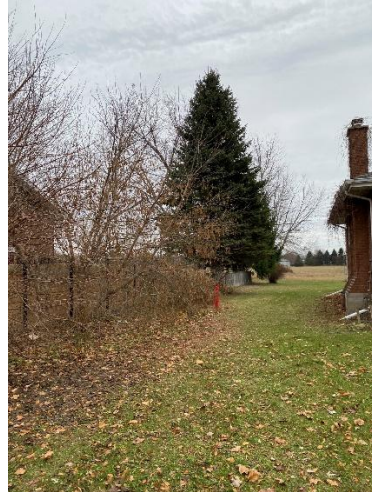
TREE ID: 2-4
ACTION: Preserve

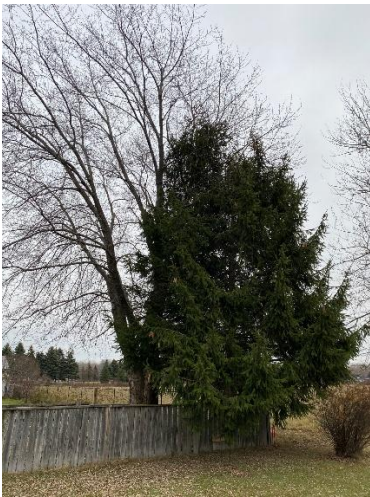
- i) Specifically, Trees #5, 11, 12, & 49-52, will require review and assessment at time of construction. They are located in close proximity to the site works.

TREE ID: 5, 11 & 12
ACTION: Preserve

- ii) When work needs to be completed within the tree protection zones, this work must be overseen by a certified arborist. In the event any pruning of branches or root pruning needs to occur, this work shall also be carried out by a certified arborist.

- iii) Trees should be assessed and monitored by a certified arborist before, during and post construction to ensure no negative impacts from the construction activities within the tree protection zone.

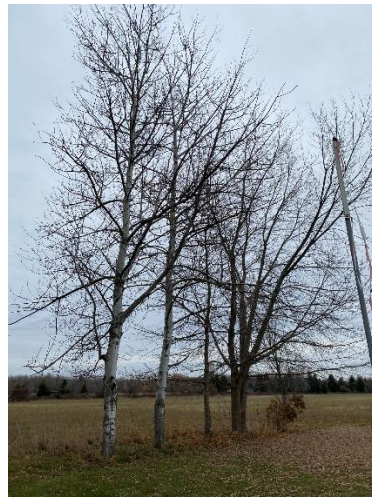
8	<i>Acer platanoides</i>	Norway Maple	21	4	Poor	Fair	Good	Moderate	2.4	Subject Site	Remove	Canopy suppressed by neighbouring trees. Trunk wounds from base to 1m.
9	<i>Populus tremuloides</i>	Trembling Aspen	38	4.5	Fair	Fair	Fair	Moderate	2.4	Subject Site	Remove	Leaning to the south. Dead branches in canopy.
10	<i>Populus tremuloides</i>	Trembling Aspen	38	6	Fair	Fair	Fair	Moderate	2.4	Subject Site	Remove	Dead branches in canopy.
11	<i>Picea abies</i>	Norway Spruce	23	3	Good	Good	Good	Low	2.4	Neighbour	Preserve	Canopy suppressed by neighbouring tree.
12	<i>Acer saccharinum</i>	Silver Maple	80-90*	9	Fair	Good	Good	Low	5.4	Neighbour	Preserve	Codominant at 1m. 4 stems.
13	<i>Acer saccharinum</i>	Silver Maple	42	5	Good	Good	Good	Low	3	Subject Site	Remove	
14	<i>Picea glauca</i>	white spruce	28	3.5	Good	Good	Good	Low	2.4	Neighbour	Preserve	
15	<i>Picea glauca</i>	white spruce	23	3	Good	Good	Good	Low	2.4	Neighbour	Preserve

TREE ID: 7-10
ACTION: **Remove**

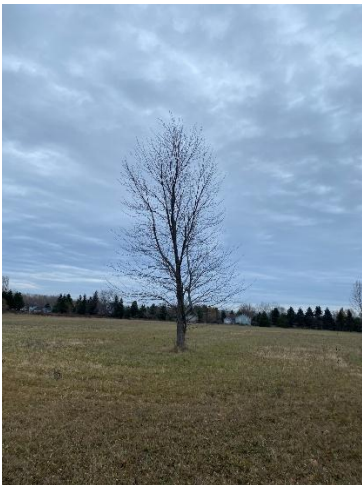
TREE ID: 13
ACTION: Preserve

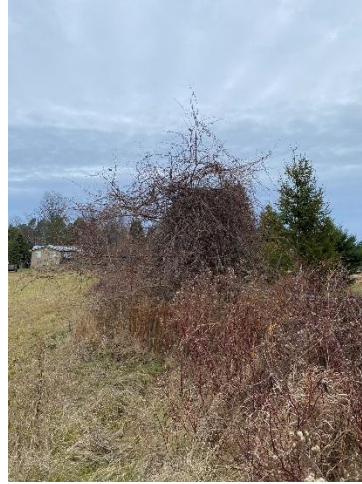
TREE ID: 19
ACTION: **Remove**

- ii) **Two (2)** privately owned trees are on the subject property will require removal but are smaller than the size required for compensation. These are trees #19 & 25.

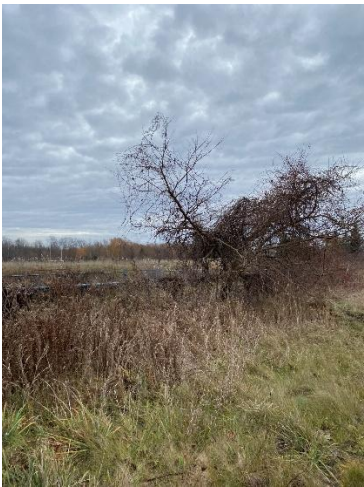
TREE ID: 25
ACTION: **Remove**

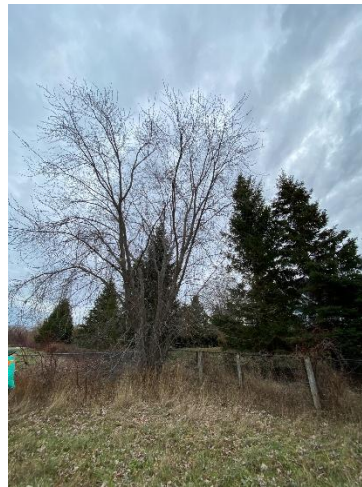
26	<i>Larix laricina</i>	Tamarack	13	2	Good	Good	Good	Low	2.4	Neighbour	Preserve	
27	<i>Acer saccharinum</i>	Silver Maple	44 34 45	5	Fair	Good	Good	Low	4.8	Subject Site	Remove	Old wounds on stems. 3 stems.
28	<i>Picea abies</i>	Norway Spruce	22	2.5	Good	Good	Good	Low	2.4	Neighbour	Preserve	
29	<i>Picea glauca</i>	White Spruce	22	2.5	Good	Good	Good	Low	2.4	Neighbour	Preserve	
30	<i>Picea glauca</i>	White Spruce	20	2	Good	Good	Good	Low	2.4	Neighbour	Preserve	
31	<i>Malus spp.</i>	Common Apple	18	2	Fair	Fair	Good	Low	2.4	Neighbour	Preserve	Significant lean to the east.
32	<i>Picea abies</i>	Norway Spruce	23	2	Good	Good	Good	Low	2.4	Neighbour	Preserve	
33	<i>Picea abies</i>	Norway Spruce	33	4	Good	Good	Good	Low	2.4	Neighbour	Preserve	
34	<i>Pinus strobus</i>	Eastern White Pine	24	1.5	Good	Good	Good	Low	2.4	Neighbour	Preserve	
35	<i>Prunus spp.</i>	Cherry	16 20	2.5	Fair	Good	Good	Low	2.4	Neighbour	Preserve	Codominant at 30cm.

TREE ID: 27
ACTION: **Remove**

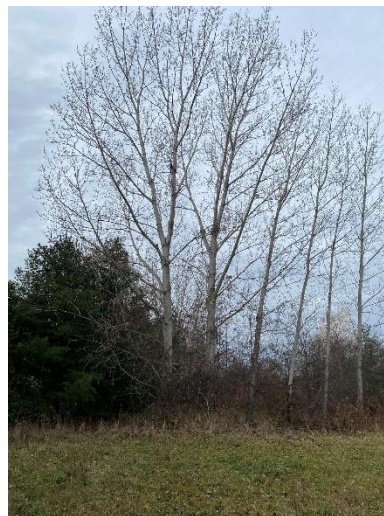
TREE ID: 48-54
ACTION: Preserve

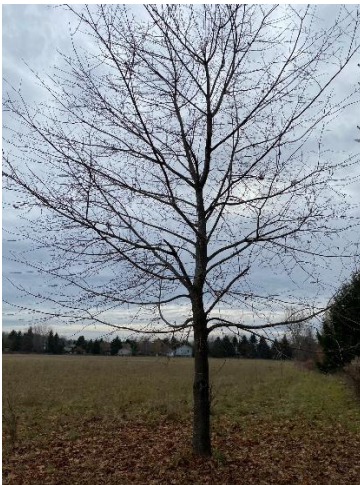
ID	Botanical Name	Common Name	DBH (cm)	Radius (m)	Trunk Integrity	Crown Structure	Crown Vigor	Hazard Rating	Tree Protection Zone (m)	Ownership	Directive	Comments
61	<i>Acer platanoides</i>	Norway Maple	24	3	Good	Fair	Fair	Low	2.4	Subject Site	Remove	Broken branches though canopy.
62	<i>Robinia pseudoacacia</i>	Black locust	13	2	Good	Good	Good	Low	2.4	Neighbour	Preserve	
63	<i>Picea abies</i>	Norway Spruce	28	3	Good	Good	Good	Low	2.4	Neighbour	Preserve	
64	<i>Picea abies</i>	Norway Spruce	26	3.5	Good	Fair	Good	Low	2.4	Neighbour	Preserve	Suppressed by neighbouring trees.
65	<i>Picea abies</i>	Norway Spruce	23	2	Good	Good	Good	Low	2.4	Neighbour	Preserve	Suppressed by neighbouring trees.
66	<i>Acer saccharum</i>	Sugar Maple	49	4	Fair	Fair	Good	Moderate	3	Subject Site	Remove

TREE ID: 61
ACTION: **Remove**

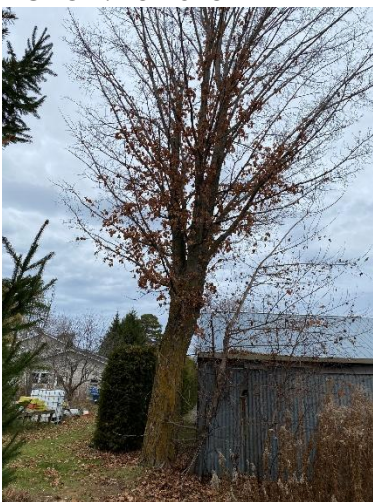
TREE ID: 66
ACTION: **Remove**
