**Addendum to Long Term Water
Supply to Clearview, Schedule B
Class EA**

**Community of Stayner
Township of Clearview**

**Township of Clearview, Stayner Long Term Water Supply,
Schedule B Municipal Class EA, Water Supply Exploration
Addendum (Golder Associates, December 2018)**

Township of Clearview Stayner Long Term Water Supply Schedule B Municipal Class EA *Water Supply Exploration Addendum*

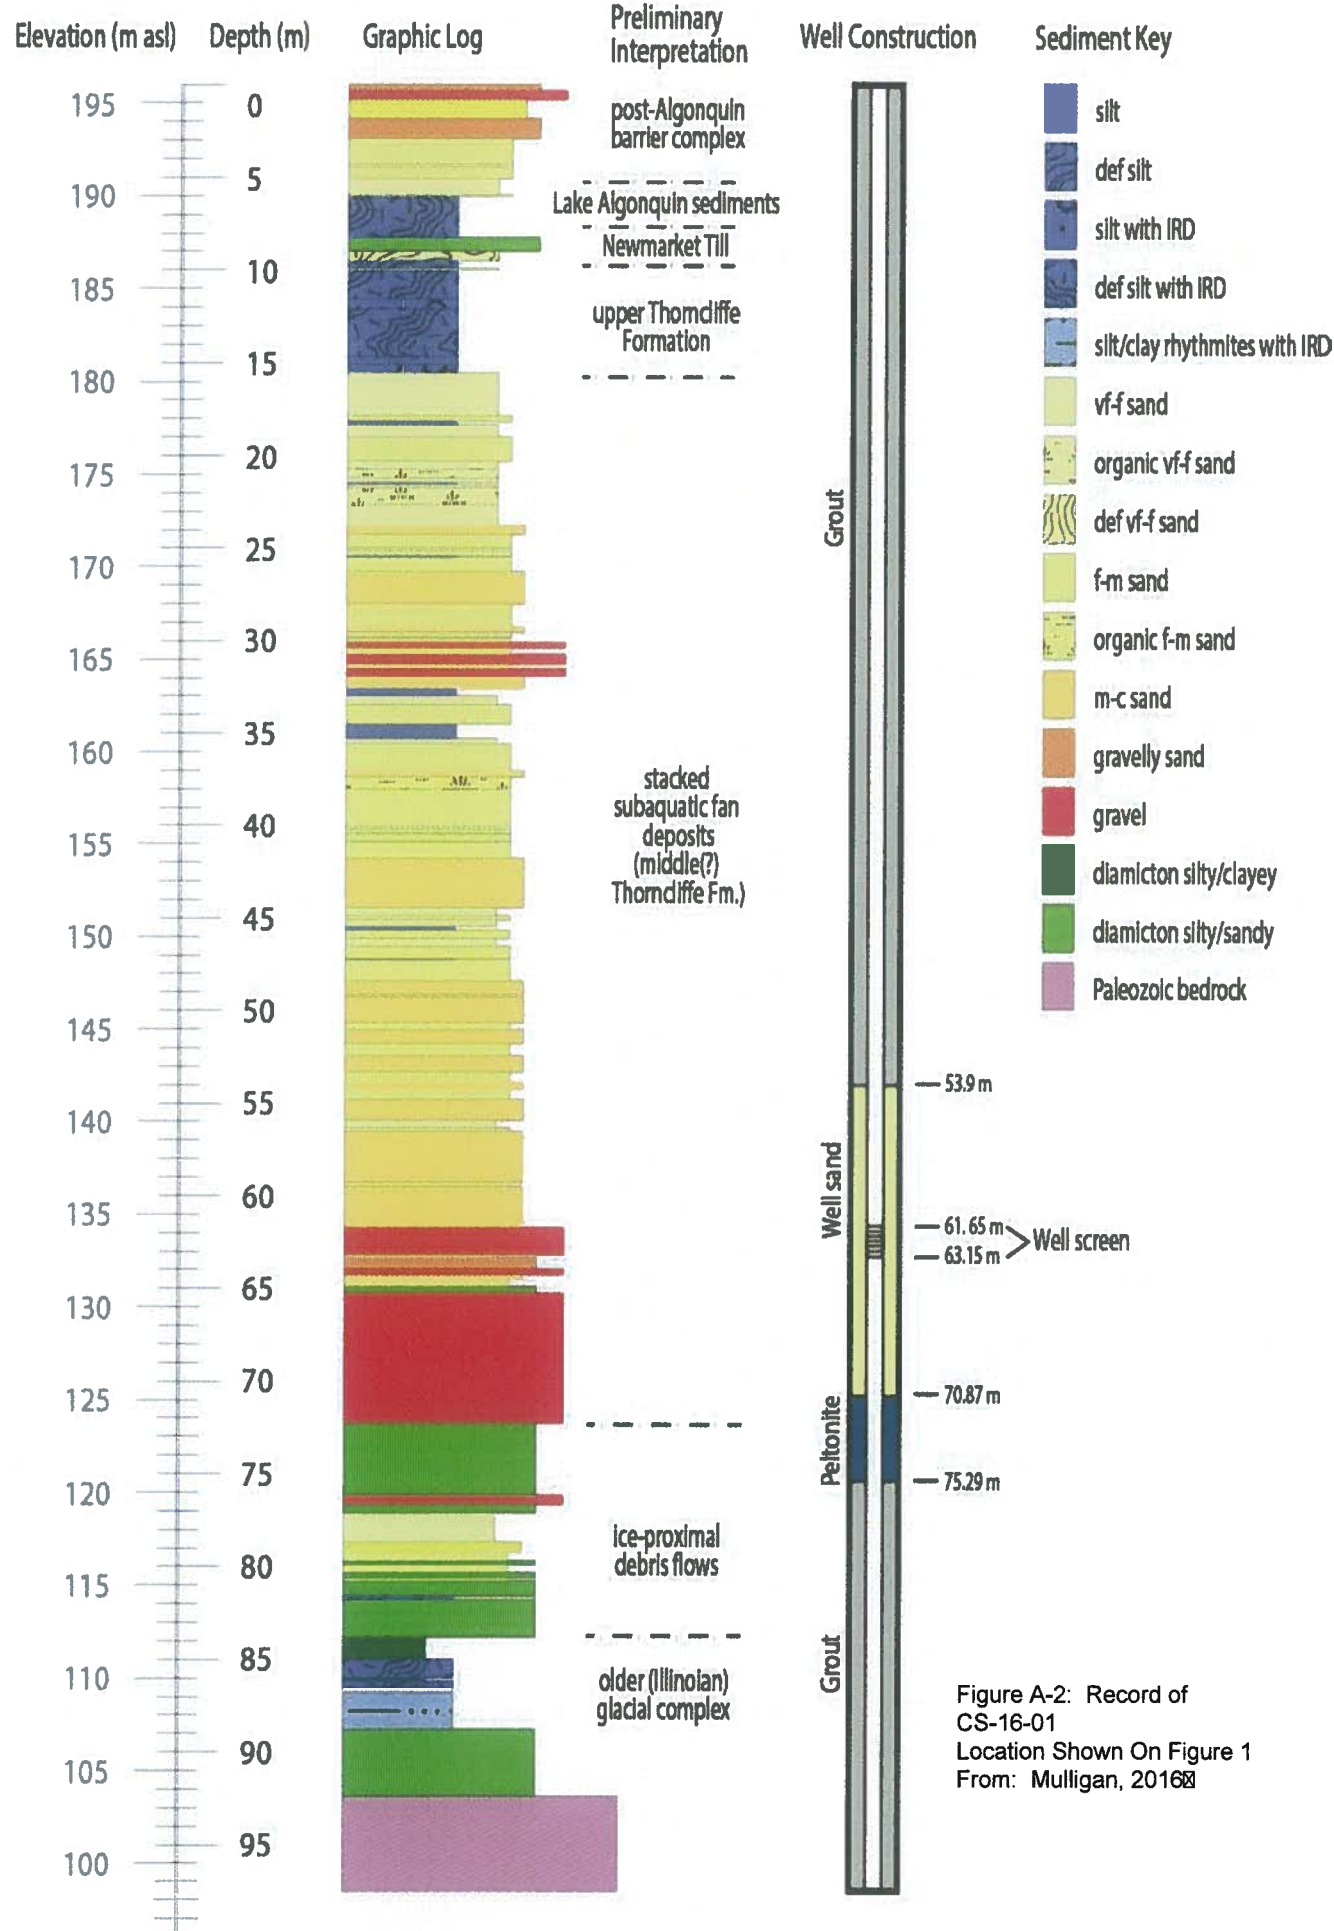
Figure A-2: Record of CS-16-01
Location Shown On Figure 1
From: Mulligan, 2016

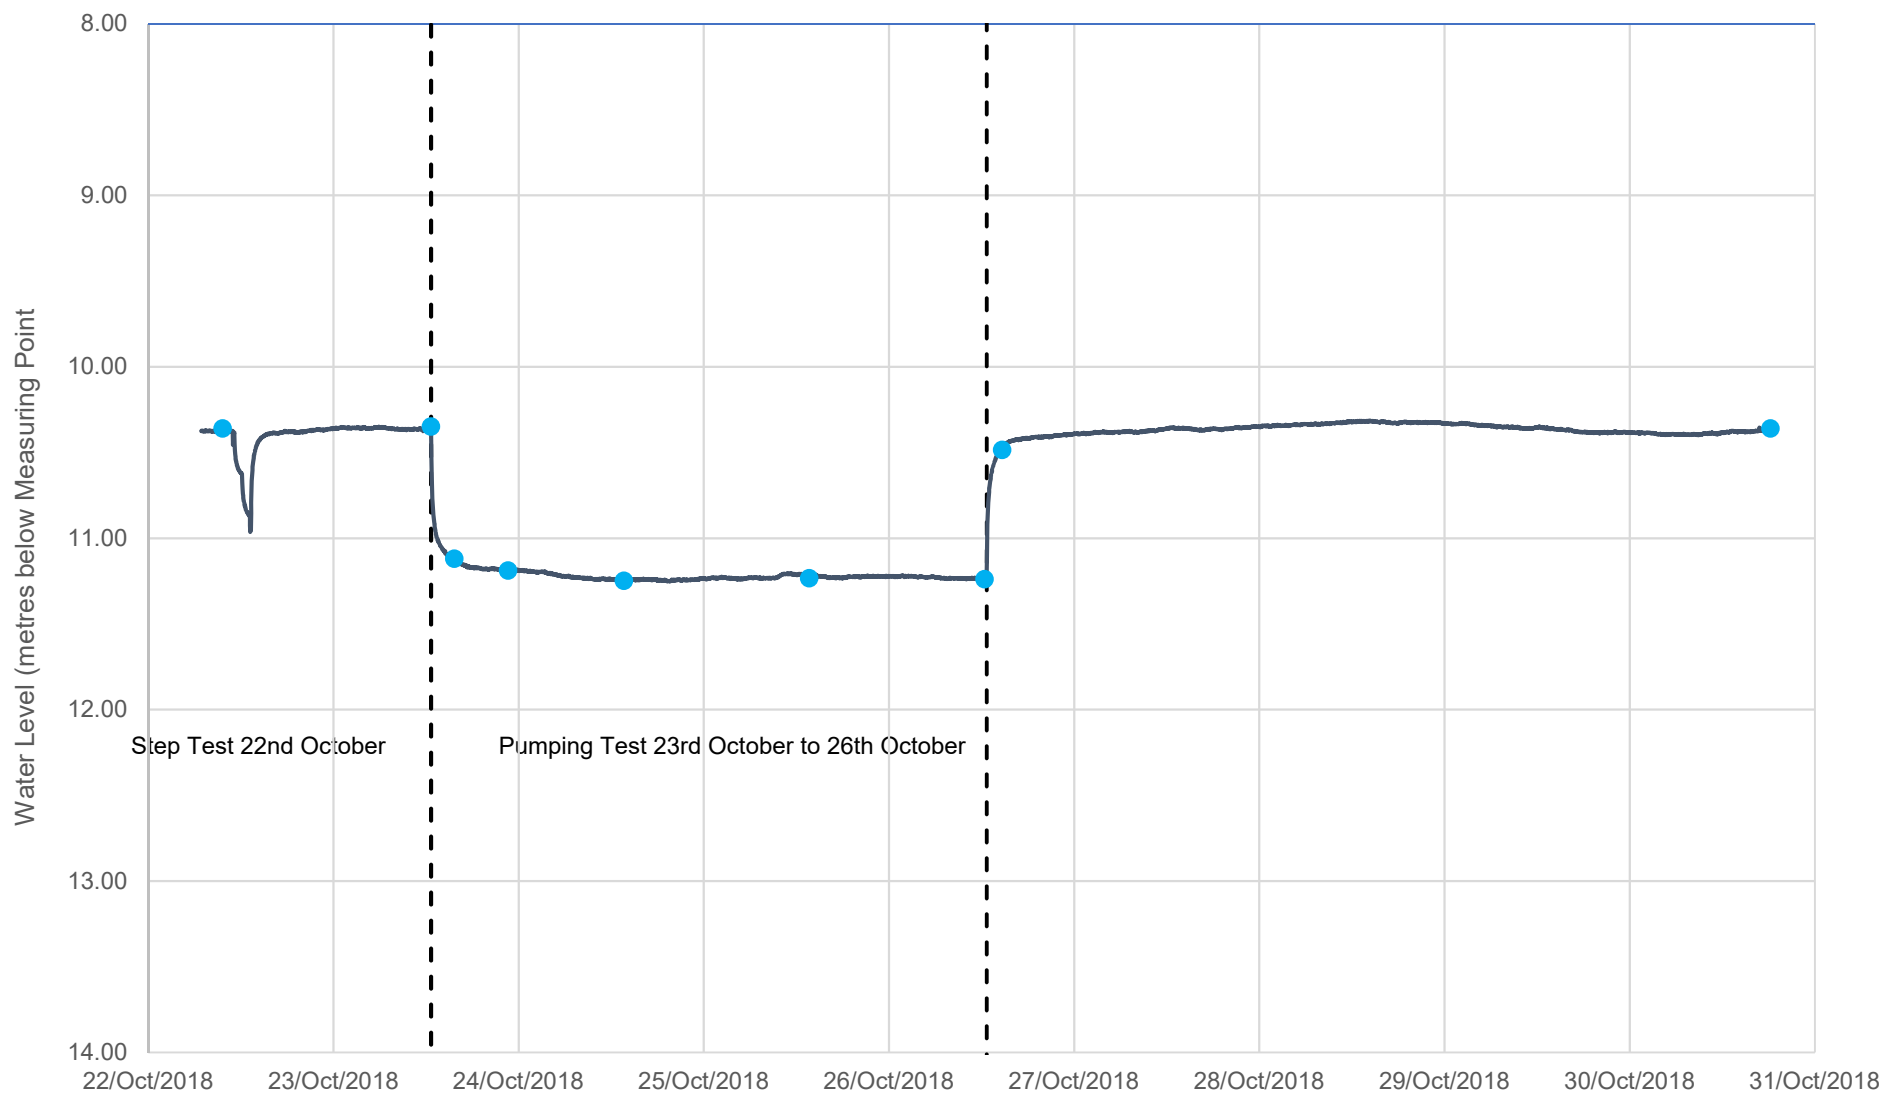
B-10

- - - 72 Hour Pump Test
- Datalogger (Baro-Adjusted)
- Hand Level

Pumping Well: TW3
 Distance from Pumping Well: 57 m
 Static Water Level: 10.37 mbmp
 Pumping Level: 11.24 mbmp
 *Levels start and Stop of Pumping Test

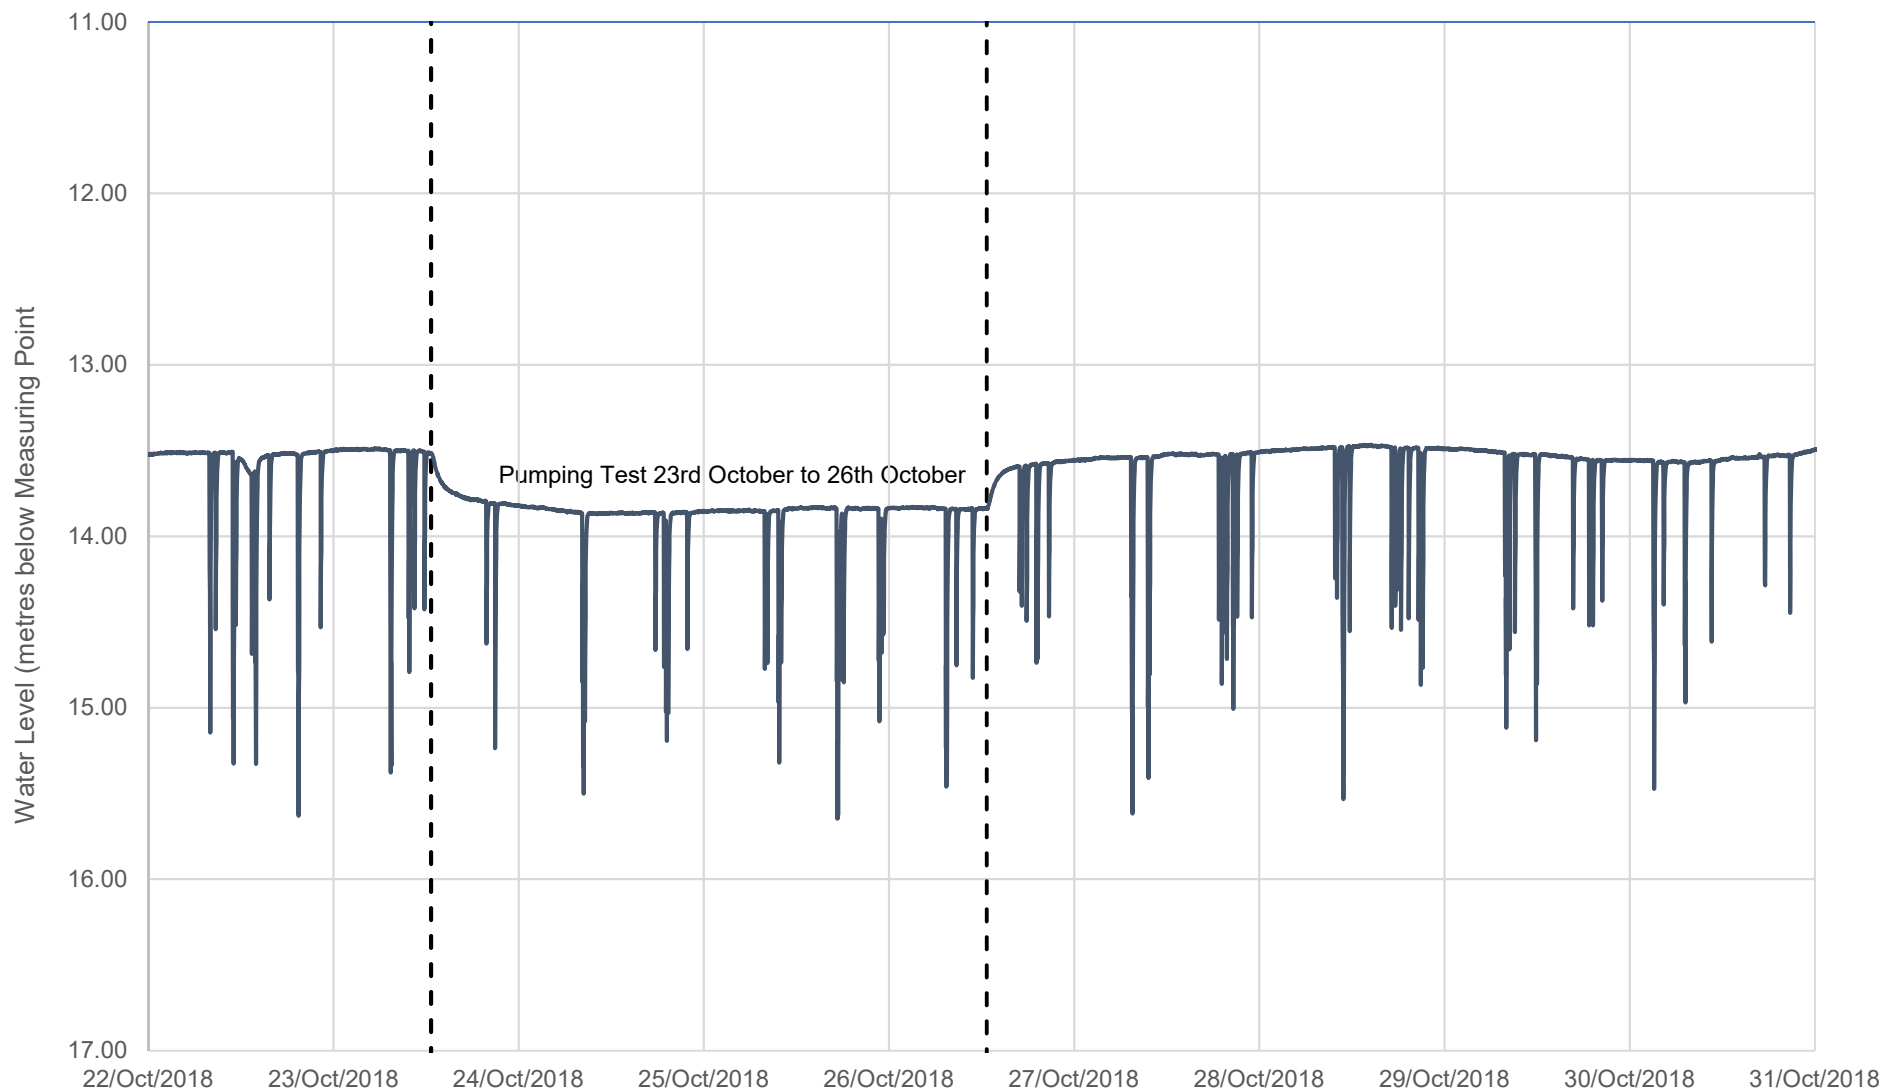
B-13

- - - 72 Hour Pump Test
- Datalogger (Baro-Adjusted)
- Hand Level

Pumping Well: TW3
 Distance from Pumping Well: 290 m
 Static Water Level: 13.52 mbmp
 Pumping Level: 13.84 mbmp
 *Levels start and Stop of Pumping Test
