ARBORIST REPORT
57 BATTEAUX ROAD DEVELOPMENT
NOTTAWA, SIMCOE COUNTY

PREPARED FOR:
NOTTAWA LIMITED PARTNERSHIP

PREPARED BY:
C.F. CROZIER & ASSOCIATES INC.

CFCA FILE NO. 1953-6180

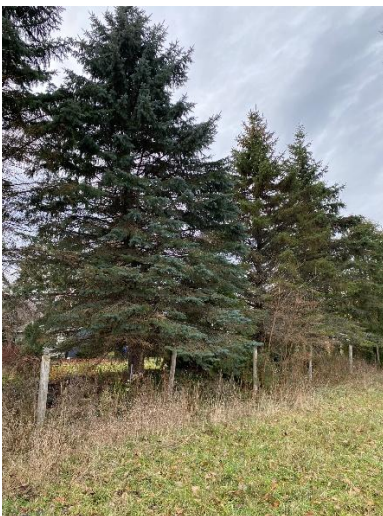
TREE ID: 45-48
ACTION: Preserve

45	<i>Picea pungens</i>	Colorado Spruce	40	3	Good	Good	Fair	Low	2.4	Neighbour	Preserve	
46	<i>Picea glauca</i>	White Spruce	34	2.5	Good	Good	Fair	Low	2.4	Neighbour	Preserve	
47	<i>Picea pungens</i>	Colorado Spruce	28	3	Good	Good	Fair	Low	2.4	Neighbour	Preserve	Suppressed by neighbouring trees.
48	<i>Pinus strobus</i>	Eastern White Pine	24	4.5	Good	Good	Good	Low	2.4	Neighbour	Preserve	
49	<i>Populus balsamifera</i>	Balsam Poplar	57	5	Good	Fair	Good	Low	3	Neighbour	Preserve	Broken branches vines in canopy.
50	<i>Populus balsamifera</i>	Balsam Poplar	52	4.5	Good	Fair	Good	Low	3	Neighbour	Preserve	Cavity in trunk two thirds of the way up. Broken branches.
51	<i>Populus balsamifera</i>	Balsam Poplar	31	3	Poor	Good	Good	Moderate	2.4	Neighbour	Preserve	Leaning to the north. Damage girdling half way up trunk.
52	<i>Populus balsamifera</i>	Balsam Poplar	23	3	Good	Fair	Good	Low	2.4	Neighbour	Preserve	
53	<i>Populus balsamifera</i>	Balsam Poplar	19	2	Good	Good	Fair	Low	2.4	Neighbour	Preserve
